**THE WHITE ANT CO.**  
TERMITE TITE BARRIER SYSTEMS

**VERTICAL FIX BARRIER**  
**BARRIER TYPE SB4 / AB4 / AB5**  
**FORMED / BOXED TYPE SLAB**

## TYPICAL PIPE PENETRATION DETAIL. CORRUGATED DISC FLANGES TYPE SFC---

# TYPICAL PIPE PENETRATION DETAIL. (CORRUGATED DISC FLANGES TYPE SFC- & PVC P2-) COPPER PIPES PENETRATING THE TERMITE PIPE FLANGE

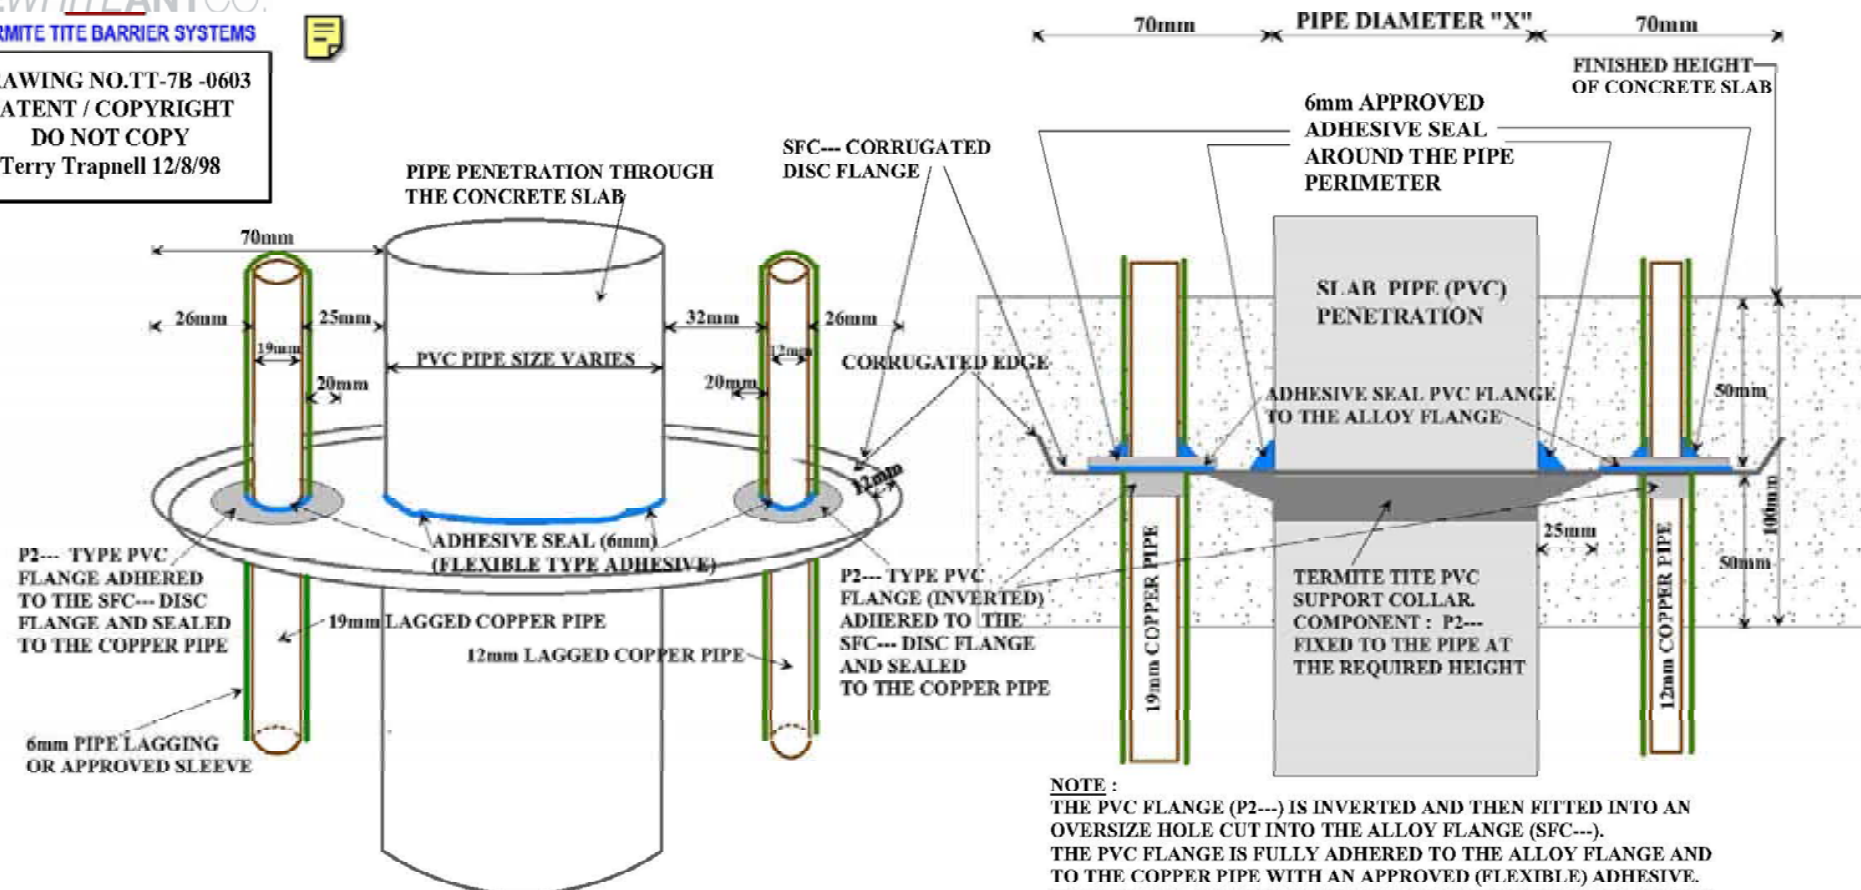
DRAWING NO. TT-7B -0603  
PATENT / COPYRIGHT  
DO NOT COPY  
Terry Trapnell 12/8/98

**NOTE :**  
THE PVC FLANGE (P2---) IS INVERTED AND THEN FITTED INTO AN OVERSIZE HOLE CUT INTO THE ALLOY FLANGE (SFC---).  
THE PVC FLANGE IS FULLY ADHERED TO THE ALLOY FLANGE AND TO THE COPPER PIPE WITH AN APPROVED (FLEXIBLE) ADHESIVE.  
THE PURPOSE OF THIS EXERCISE IS TO ENSURE THAT THE COPPER PIPES DO NOT COME INTO CONTACT WITH THE ALLOY FLANGE AS THIS COULD CAUSE DEGRADATION OR CORROSION

**IMPORTANT:**  
WHEN REMOVING LAGGING FROM THE COPPER PIPES PLEASE ENSURE THAT NO DAMAGE OCCURS TO THE COPPER PIPE AND THAT THE LAGGING IS REPLACED TO ITS ORIGINAL CONDITION OR THE PIPE SLEEVED TO ENSURE THAT NO CONCRETE COMES IN CONTACT WITH THE COPPER AS THIS WILL CAUSE THE COPPER PIPE TO CORRODE
